## Spiral Welding & Onsite Machining

### Boat Lift Shaft Repair

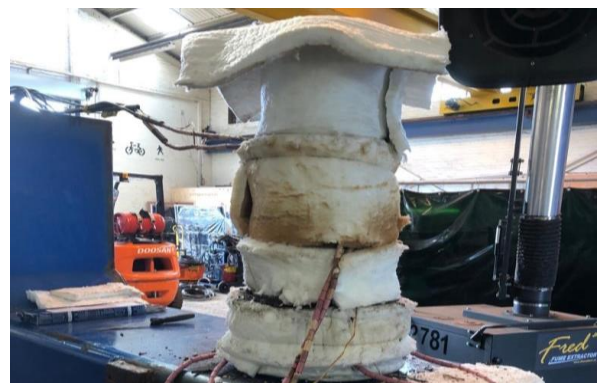
Due to a collapsed wheel bearing, the shaft had sustained damage. Furthermore, the shaft was heavily pitted and corroded as a result of the boat lift spending long durations in salt water during the execution of lifting and loading vessels in and out of the sea.

Upon arrival, the shaft was further inspected, and a full report was developed to capture all pre-machining measurements and document the condition, outlining the damage. The repair process then began with heat treatment of the shaft to allow the Fortress Energy Fabrication team to weld up both parts of the shaft where the bearings would be placed.
